#### FLORENCE COPPER INC.

Subject: Weekly Monitoring Report for Week Ending 05/18/2019

Florence Copper, Production Test Facility

Aquifer Protection Permit No. 106360, LTF 61845

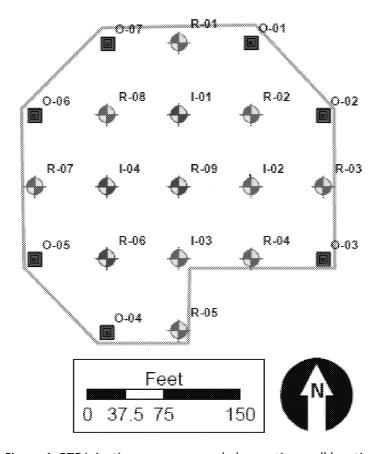
Figure 1. PTF injection, recovery, and observation well locations

A map showing the location of the PTF injection, recovery, and observation wells is included as Figure 1.

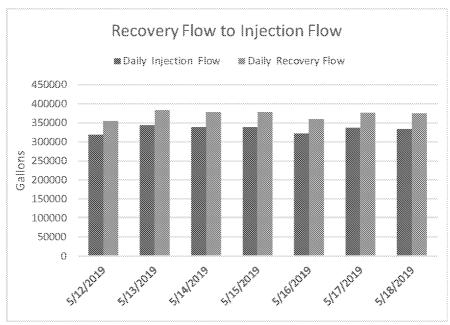
Figure 2. Recovered volume to injected volume

A summary of the injected and recovered volumes for the week 5/12/2019 to 05/18/2019 is included in Table 1. The total injected and recovered volumes for the PTF as a daily total are also presented on Figure 2.

During the reporting period no exceedance of the alert level was measured for recovered volume to injected volume. The alert level is the recovered volume shall exceed the injected volume.

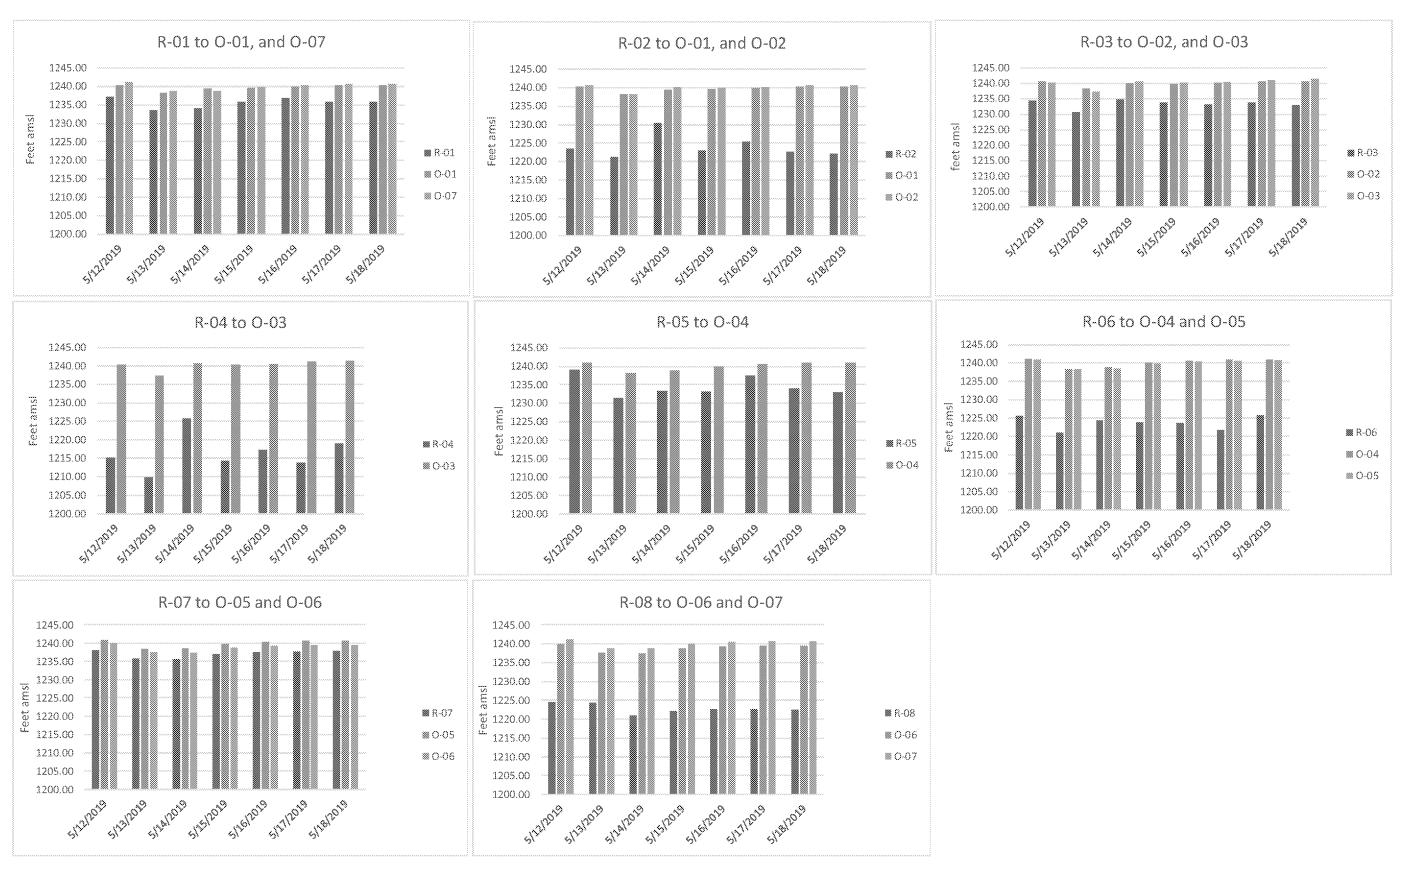
Figure 3

Figure 3. Recovery and observation well pairs

Table 2 includes a summary of water levels in the recovery and observation well pairs. Hydrographs showing the water level elevation for each recovery well and observation well pair are included in Figure 3.

During the reporting period, there was no exceedance of the alert level for the inward hydraulic gradient. The alert level for the inward hydraulic gradient is that the water level elevation in the paired observation well must be a minimum of 1 foot higher than the paired recovery well.
